6.2 SUBBASIN 1 STREAM HABITAT CLASSIFICATION RESULTS

6.2.1 General Characteristics (Boise Creek: RM 0.0 – 1.2)

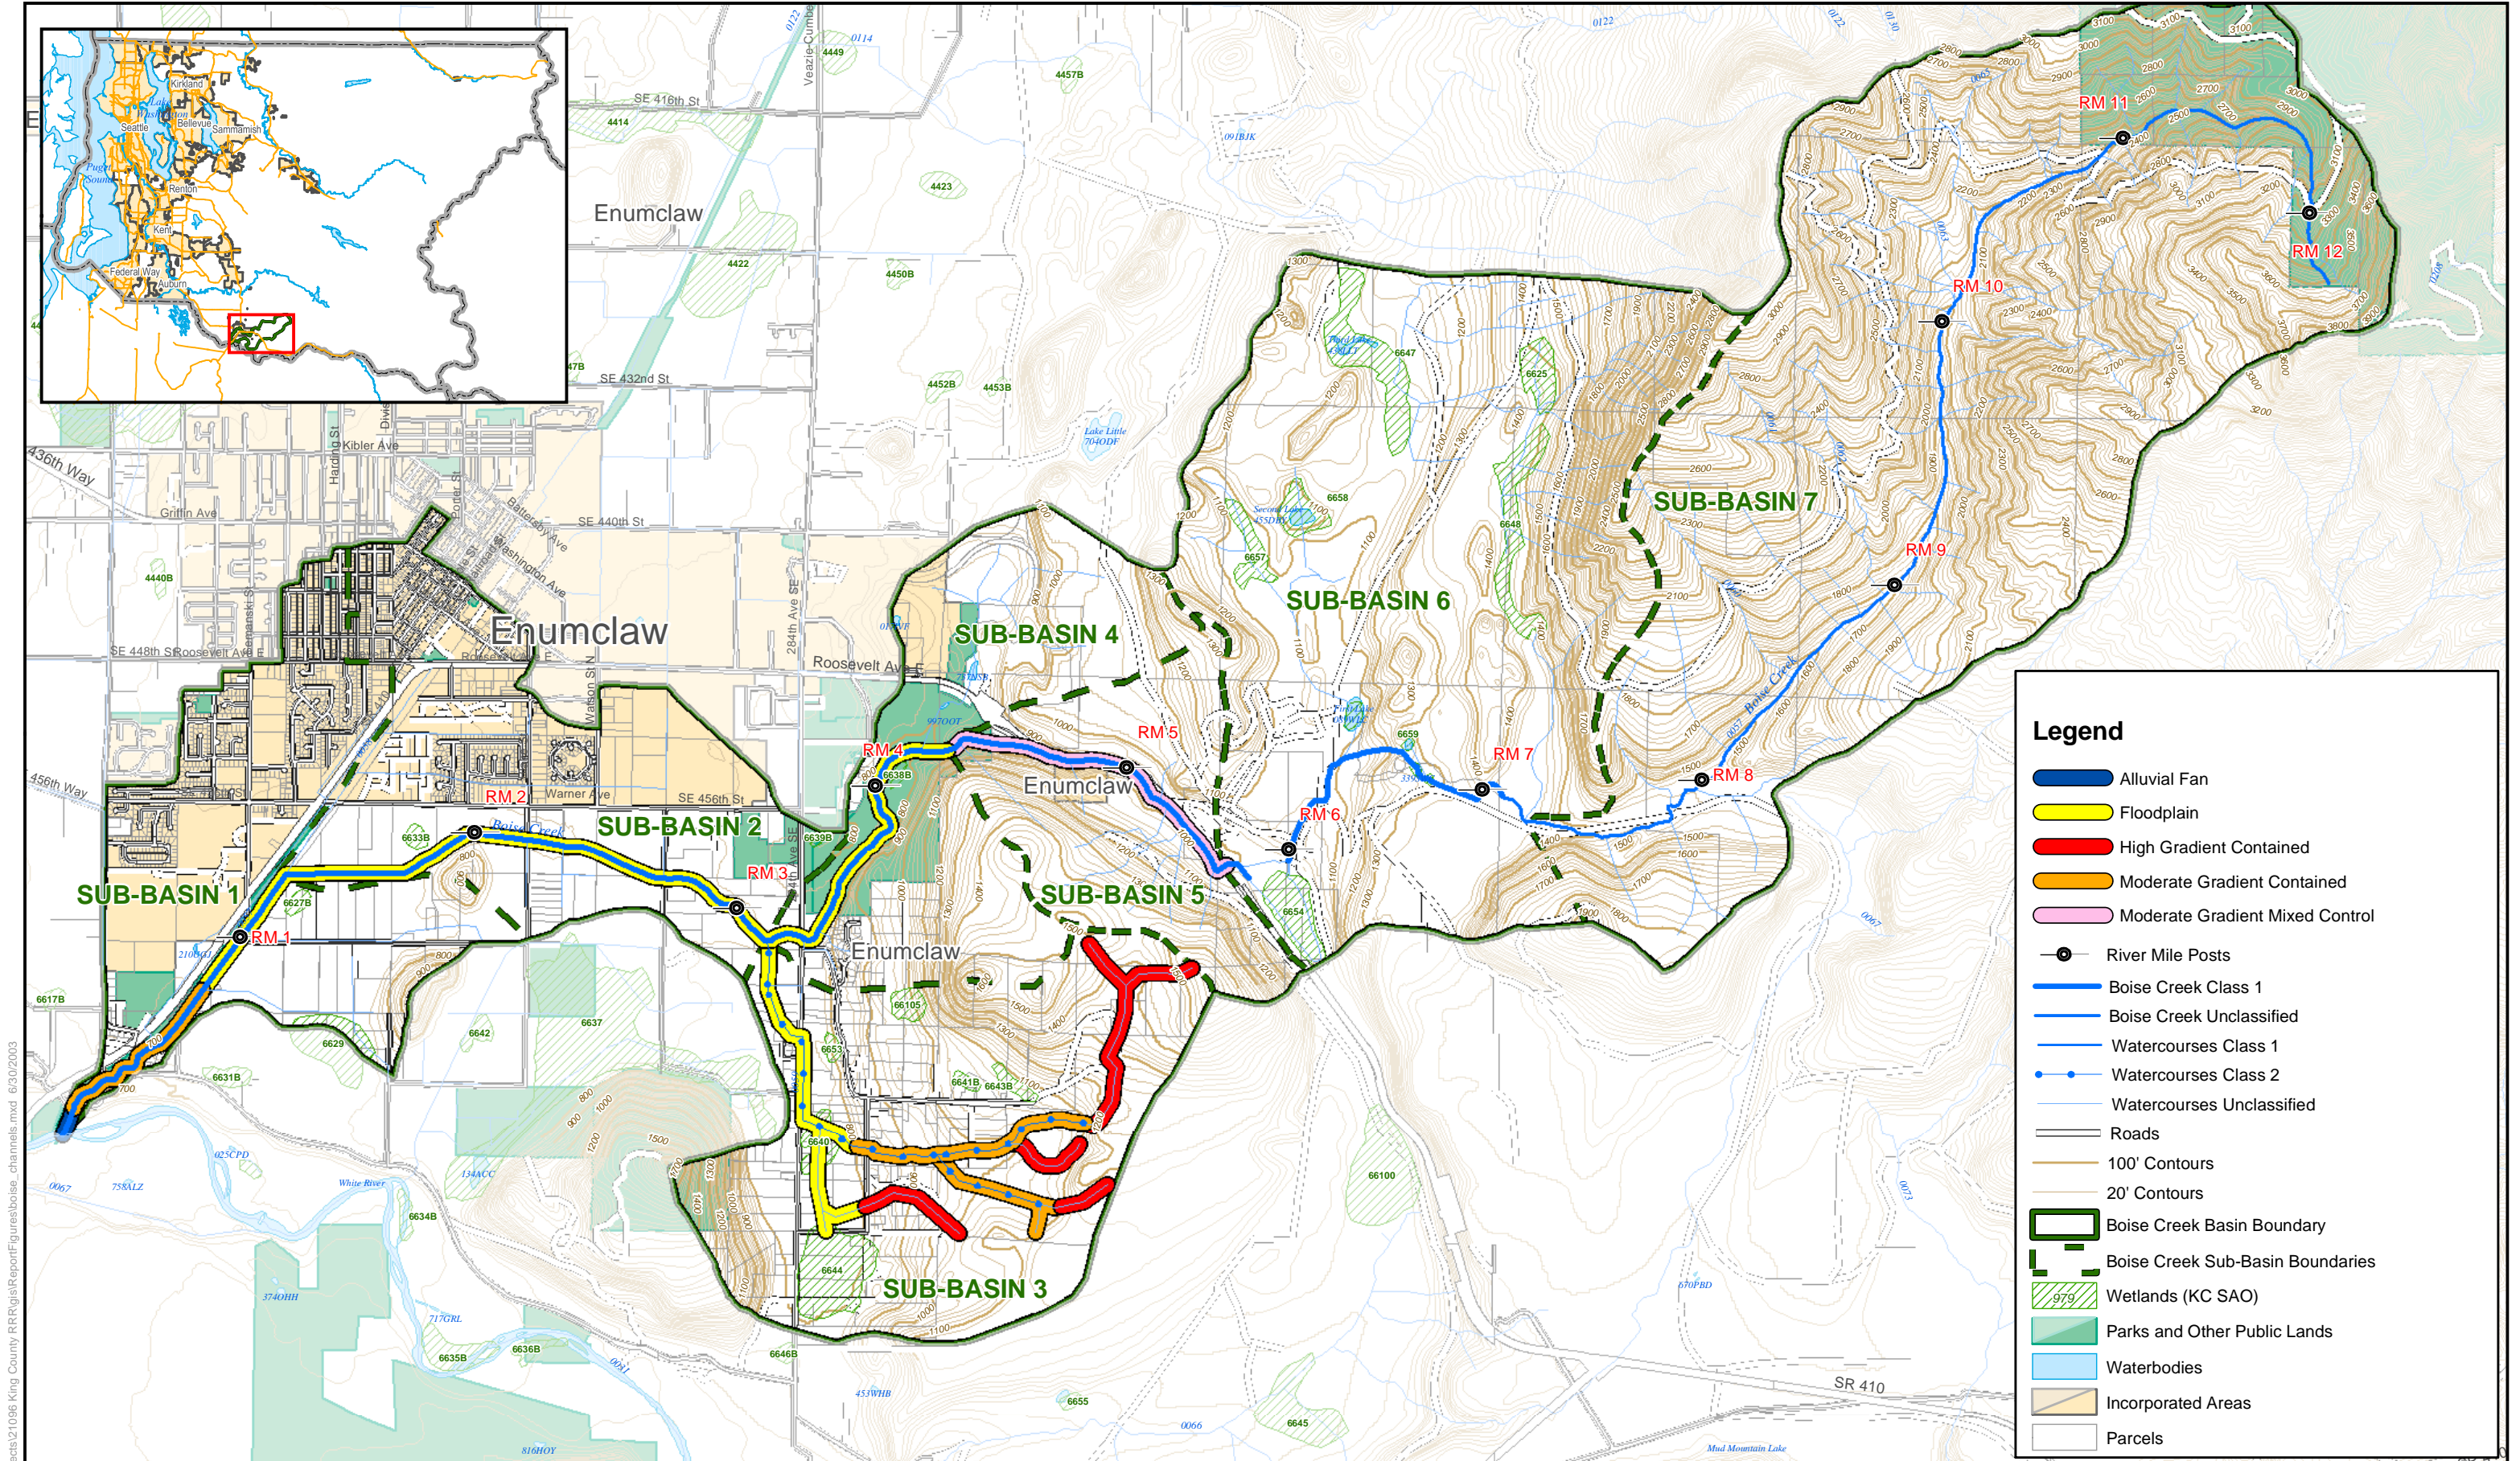
Subbasin 1 of Boise Creek has two distinct reaches. From RM 0.0 to 0.8 is a moderate-gradient contained channel that flows through a steep ravine vegetated with relatively abundant native riparian vegetation, including deciduous trees and conifers, as shown in Figure 6-1. However, field investigations and examination of historical maps reveal that much if not all of this segment of Boise Creek has been relocated into the ravine, as well as the flatter gradient area downstream of Mud Mountain Road. From RM 0.8 to 1.2, the subbasin is a floodplain channel type that has been degraded by channelization, straightening, construction of levees and revetments, and removal of riparian habitat. It is likely that this upper reach historically was a meandering stream, as is commonly found with floodplain channel types. Table 6-5 summarizes the channel types in Subbasin 1.

Although the steeper portion of Subbasin 1 has not been affected to the same degree by adjacent land use practices as other reaches, its habitat value is still relatively low because of the high channel gradient, fast stream energies, large substrate, lack of LWD and paucity of pools.

The reach downstream from Mud Mountain Road offers the greatest potential for habitat improvement in Subbasin 1. The land through which the stream flows is in public ownership and there are few impediments to restoration of a sinuous channel and floodplain, terminating in an alluvial fan at the confluence of the White River. Riparian habitat restoration and LWD placement would also improve habitat conditions in this reach.

Restoration of the channel and riparian corridor within the ravine upstream from Mud Mountain Road would be more problematic because much of the adjacent land is in private ownership and the ravine walls are extremely steep and unstable in many areas. Nonetheless, it may be possible to access the stream from a recreational trail within publicly owned right-of-way along the right bank in order to plant conifers and place LWD in certain locations.

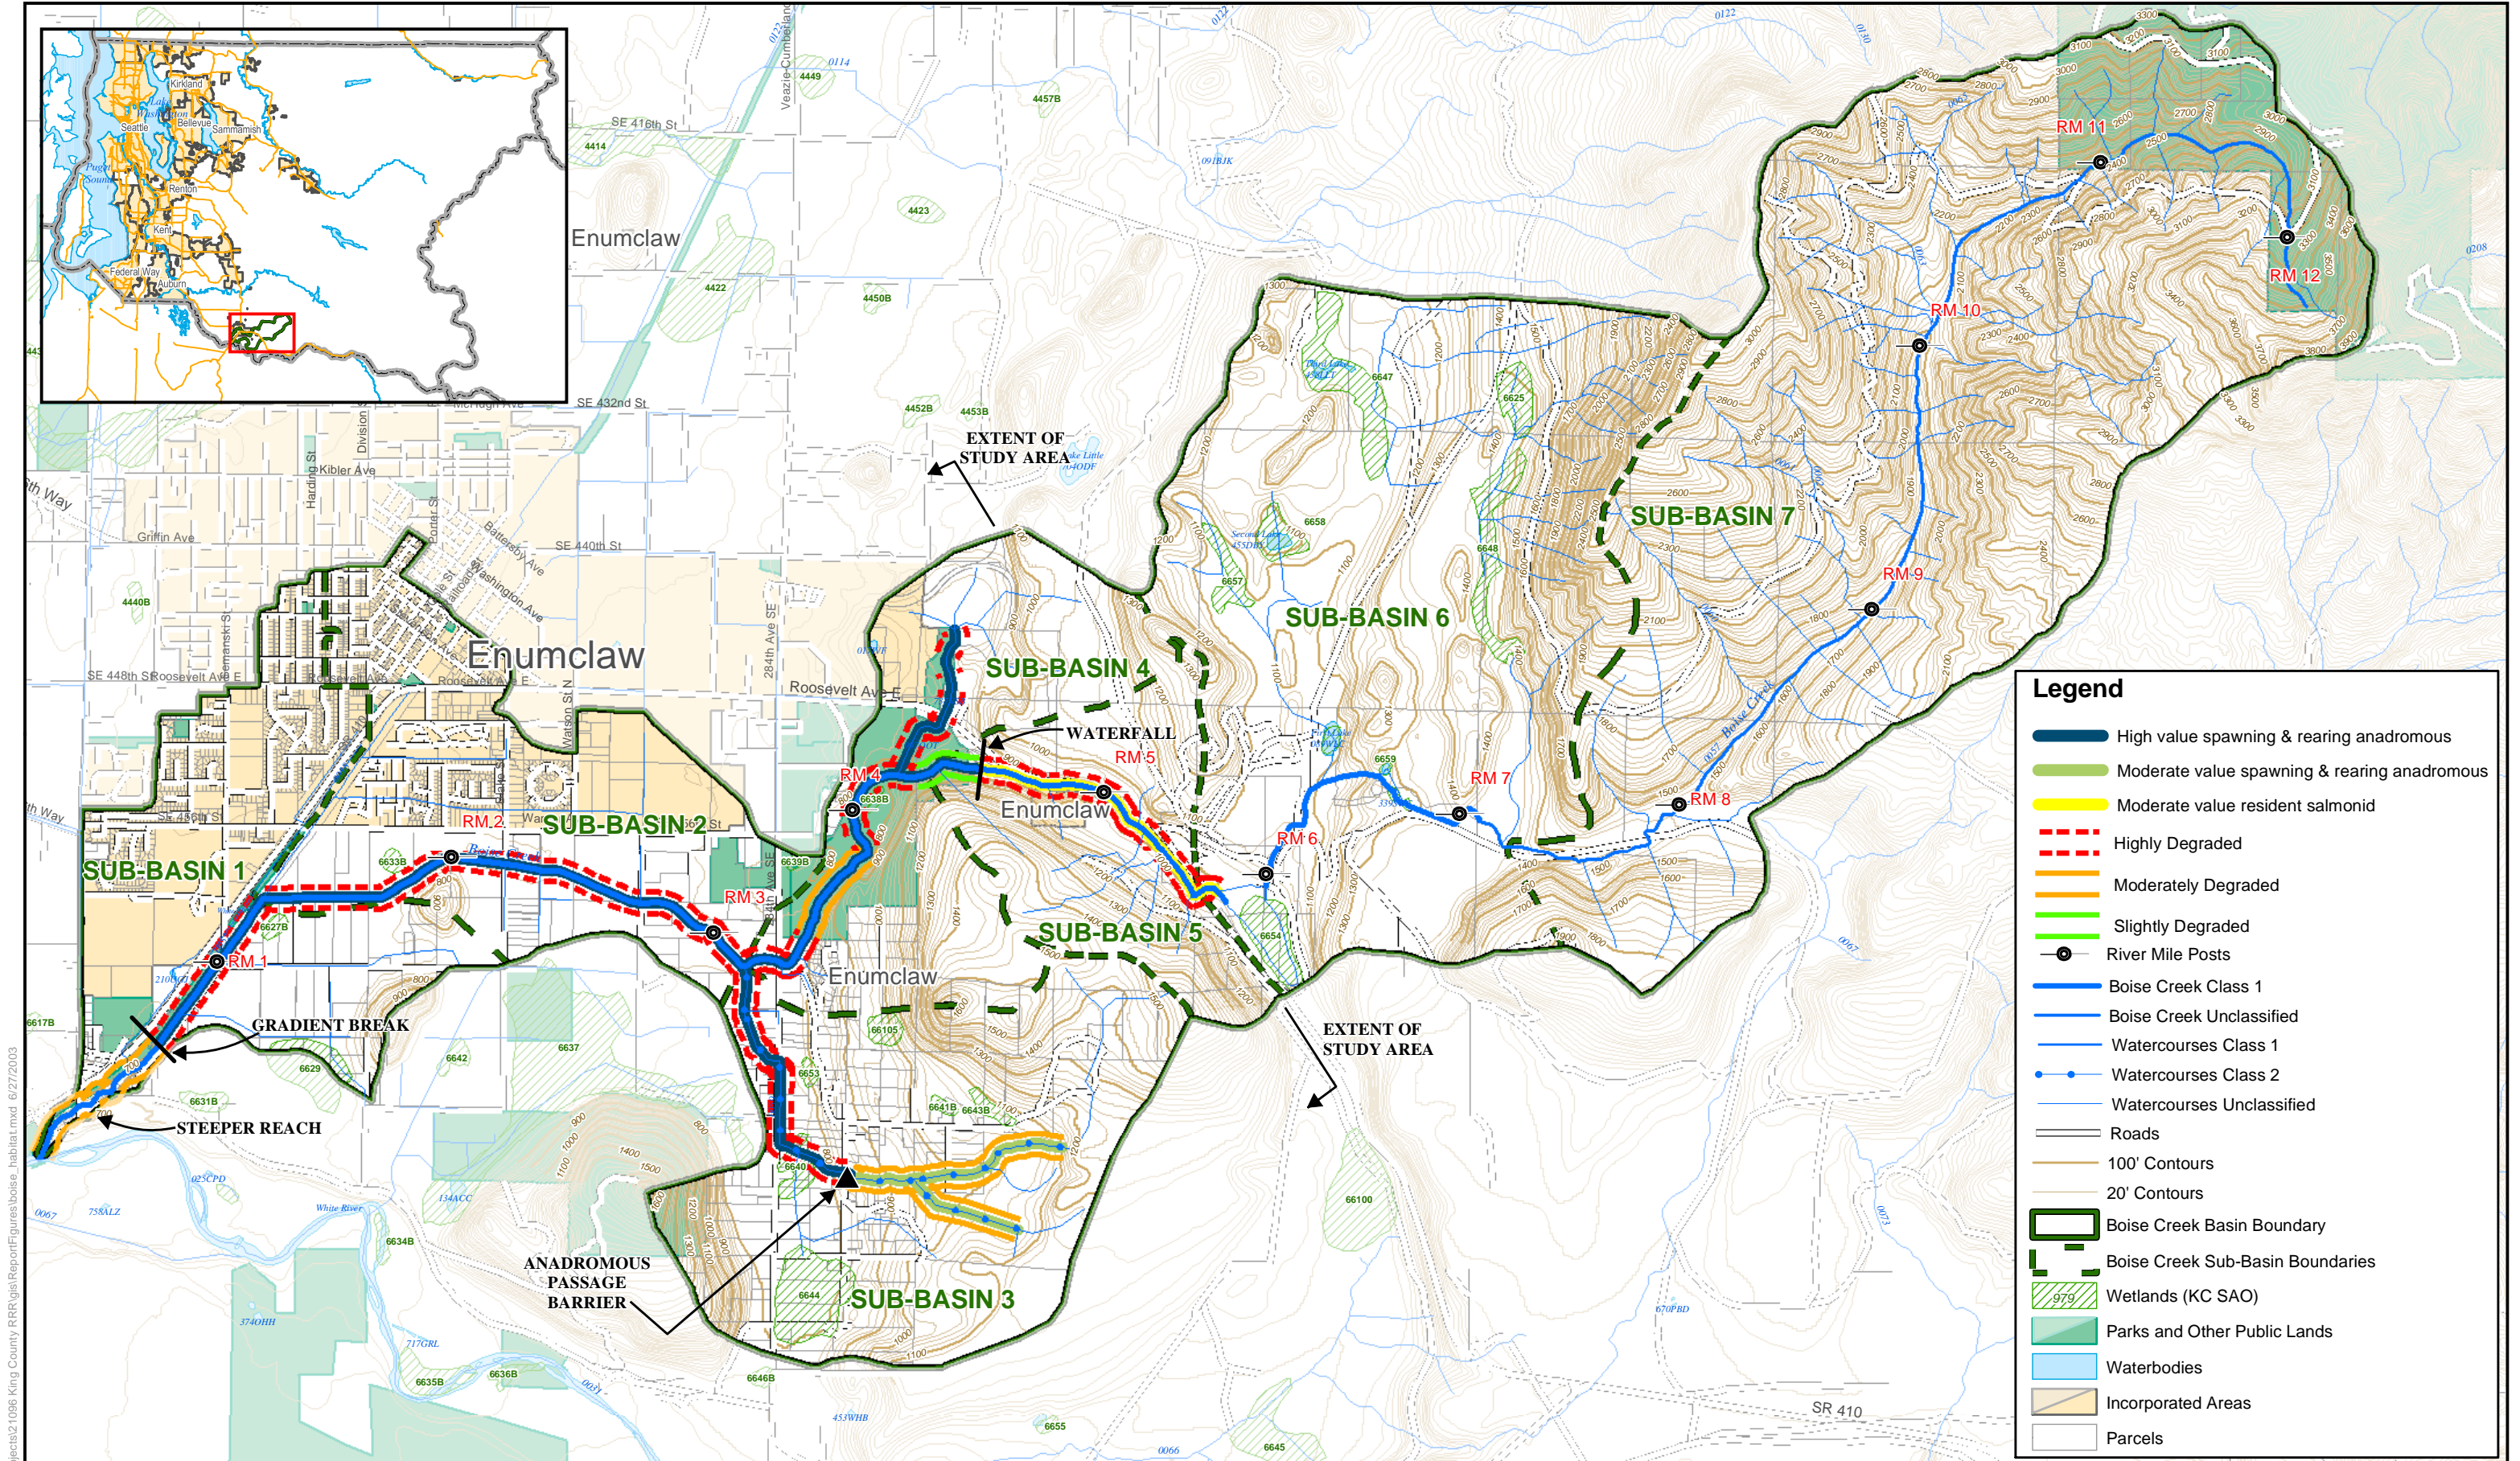
Subbasin 1 has been highly impacted by infrastructure development (construction of SR-410 and a railway that in recent years has been converted to a trail and residential and agricultural development. As a result habitat within this subbasin is in poor condition. Much of the stream channel has been channelized, straightened, and dredged, which has lead to channel incision. The riparian habitat is in moderate to poor condition due to encroachment by agricultural and rural residential development. The reach is also void of LWD. Deposition of fine sediments in this reach that have eroded from upstream areas has also degraded substrate conditions. Restoration efforts in this subbasin should address the overall function of the subbasin. Figure 6-2 shows the habitat value, rating, and condition of the stream.
